## 6.1.3 T210053 PA - Demolition of an Existing Fire Damaged Heritage building at 19-21 Woods Street, Beaconsfield

#### Old Beaconsfield Post Office - 19-21 Woods Street Beaconsfield Review of Heritage Assessment

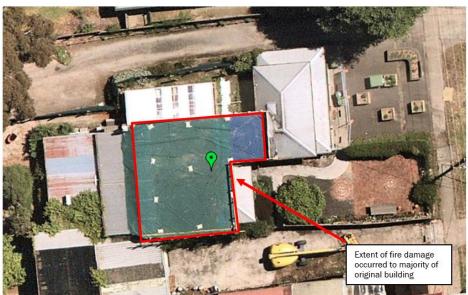
In early November 2020 the building was subject to a fire in which according to Council's building file the roof frame of the mid-section of the building (original section of the building), which included the kitchen and dine-in area was completely burnt and remaining members for trusses were completely charred. It was also noted that a section of the ceiling was completely collapsed and parts of the roof sheeting had also been removed by firefighters to help control the fire.

Advice from Council's Deputy Municipal Building Surveyor is that the centre part of the building was severely damaged by fire, and while the structure is still standing, the framing members have been reduced in size by the fire, so are not as structurally strong as they should be. Water damage was also caused from firefighting throughout the entire building, causing further damage to the framing members (i.e. mould and rot).

Figure 5: Extent of fire damage to buildings (NearMap image dated 25 Nov 2020)

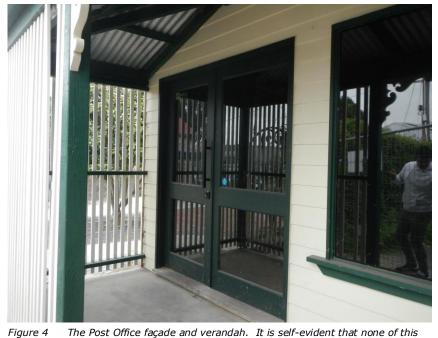
4 The Post Office façade and verandah. It is self-evident that none of this dates from c.1910 – more probably from the second half of the 20<sup>th</sup> century.

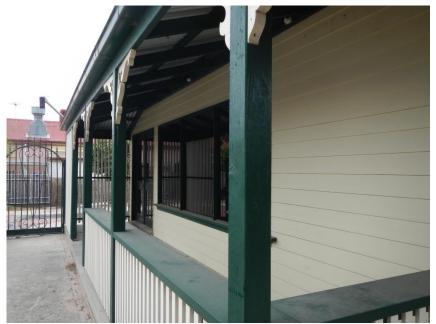
Figure 5The Post Office verandah. It is self-evident that none of this dates from<br/>c.1910 – more probably from the second half of the 20th century.

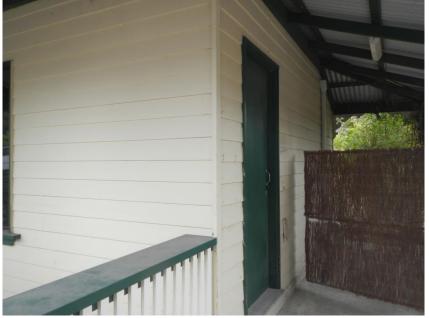
Figure 6 The back of the Post Office. The cladding is building sheet not weatherboard.

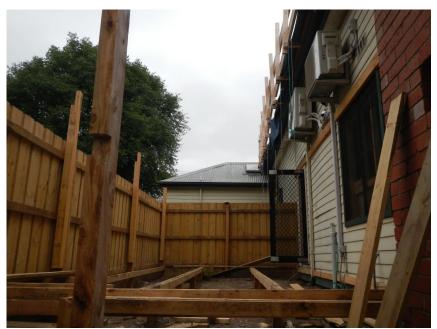
Figure 7The North side of the Post Office. The cladding is building sheet not<br/>weatherboard. The chimney is not particularly significant. (Ref. Fig. 9)

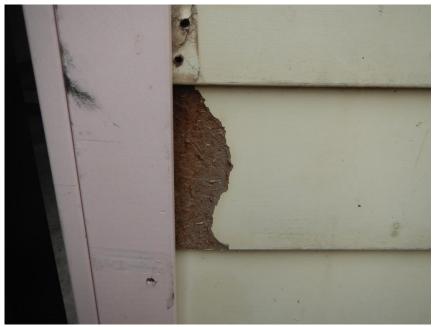
Figure 8 The North side of the Post Office. The cladding is compressed fibre building sheet not weatherboard.

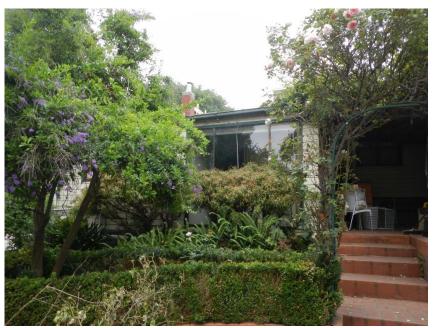
The back verandah and addition to the Post Office is of recent origins. Figure 9

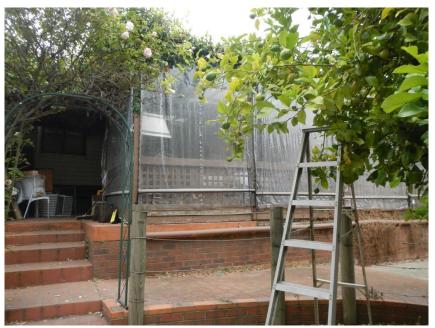
Figure 10 The back verandah to the Post Office is of recent origin and is utilitarian and rudimentary.

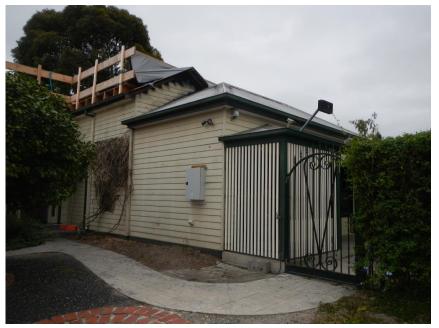
Figure 14 The South elevation of the Post Office and damaged roof. The gabled section may have been part of the residence.

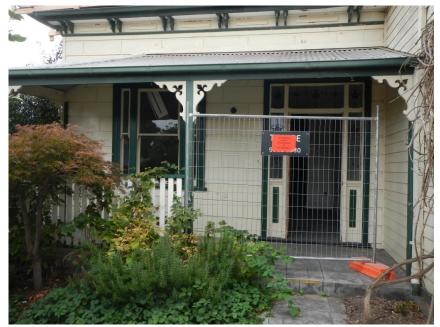
Figure 15 The timber block-fronted façade to the residence.

- i. The front window as pictured in Figure 15 of the Heritage Assessment prepared by The Anthemion Group Pty Ltd;
    - ii. The front door and all lead lighting as pictured in Figure 16 of the Heritage Assessment prepared by The Anthemion Group Pty Ltd;

- The original block weatherboards from the façade as pictured in Figure 15 of the Heritage Assessment prepared by The Anthemion Group Pty Ltd;
    - iv. All timber fretwork as identified in the Heritage Assessment prepared by The Anthemion Group Pty Ltd; and

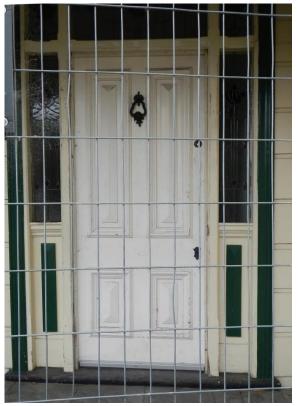
Figure 16 The doorcase to the residence.

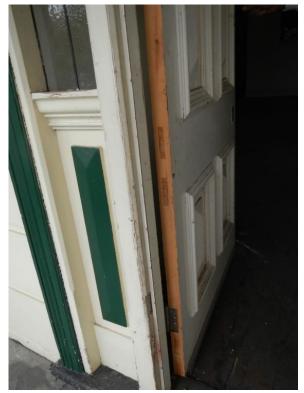
Figure 17 The fact that the door has been cut down lends support to the likelihood that the door is salvage from elsewhere installed as a replacement rather than original otherwise there is no obvious reason as to why it was cut down.

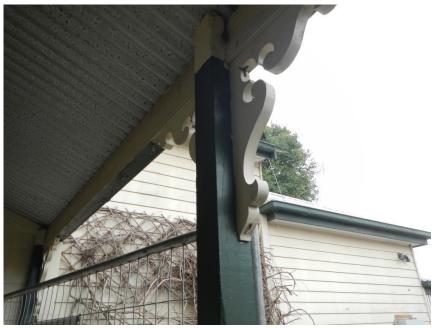
Figure 20 It is self-evident that the detailing of the verandah to the residence is not original.

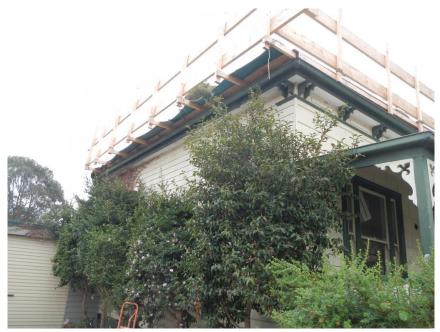
Figure 22 The damaged roof of the residence on the South side.

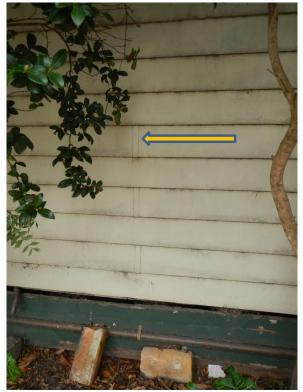
Figure 24 The cladding on the South side is similar to that on the North side of the Post Office and joints have been concealed or fixed with clips. It is not timber weatherboard.

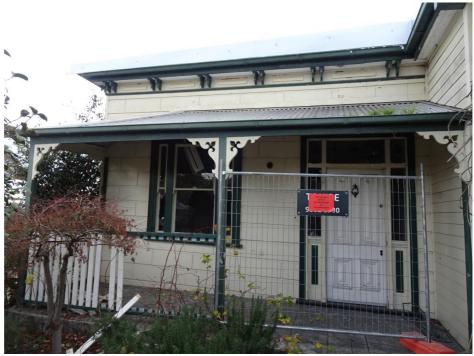
Image 2: The front façade of the c1910 dwelling is good condition and most intact. The verandah is of later date and not architecturally significant.

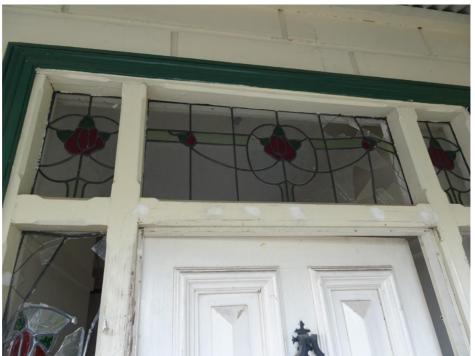
Image 3: The front door and frame complete with leadlight surround (of later date and recently vadalised).

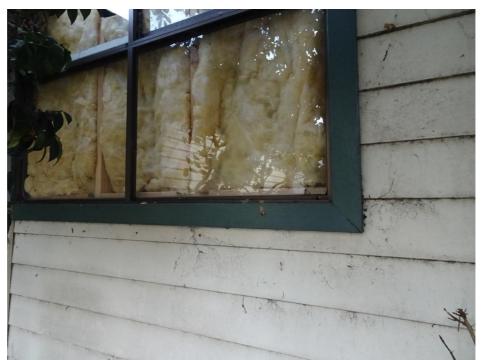
Image 4: Exterior cladding and windows on all other parts of the building are of later date and of no architectural significance.

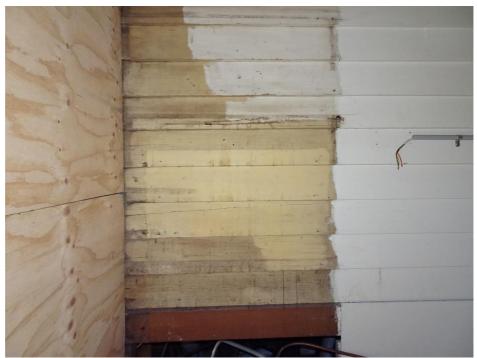
Image 6: Remnant original hardwood weatherboards located inside the former cool room area.

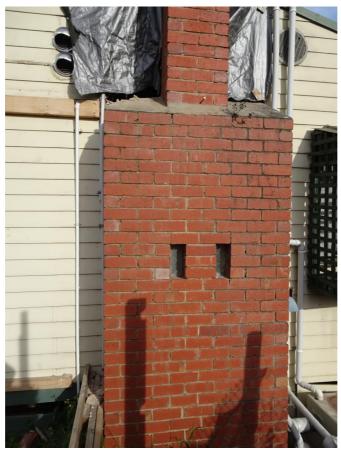
Image 7: The brick chimney remains intact and is in reasonable condition. Note the chimney lights – an important feature of Edwardian fireplace.

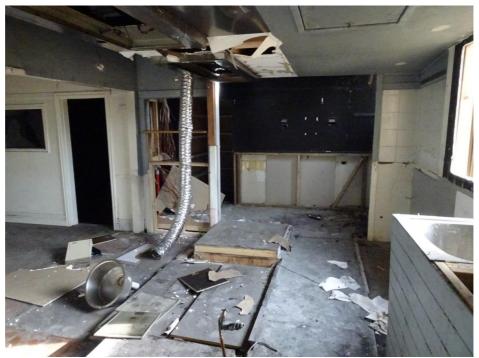
Image 12: Former kitchen area – is of no architectural significance.
