NOTICE OF AN APPLICATION FOR PLANNING PERMIT

| The land affected by the application is located at: | 12 Fraser Avenue, Beaconsfield Upper VIC 3808 L1 TP161459 |
|---|--|
| The application is for a permit to: | Alterations & Additions to a single dwelling |

Arboricultural Impact Assessment

| Prepared For: | | |
|---|--|--|
| Site Address: | 12 Fraser Avenue, Beaconsfield Upper Vic 3808 | |

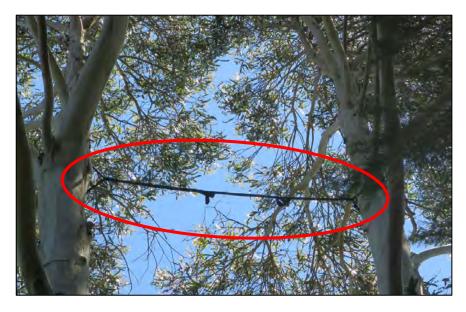
Figure 1 - Example of dynamic cable brace installed between tree components.

Dynamic cable bracing should be installed between the three leaders at a height of approximately 2/3 of the total height. Cable braces must be installed as per the manufacturer's recommendations by a suitably qualified and experiences arborist. Bracing should allow for natural movement between the unions (dynamic) but be of a sufficient strength rating to stop total failure of the unions in a high wind event.

Due to the significant bark inclusion (BI) within the main unions at the base of this tree, the weakened structure should be mitigated with additional support for it to be more safely retained in the landscape.

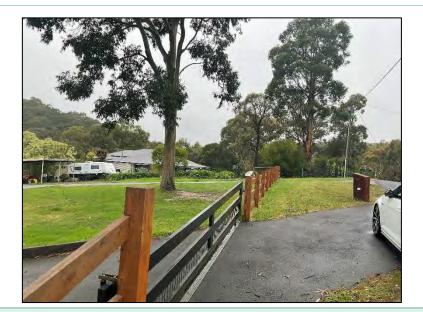
FRONT BOUNDARY FENCE VIEWED FROM THE WEST

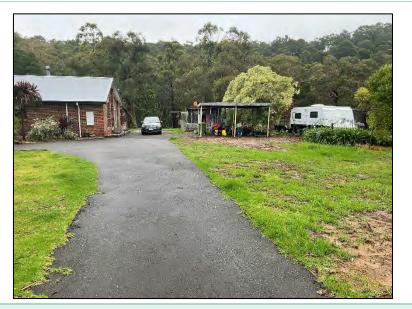
EXISTING DRIVEWAY VIEWED FROM THE NORTH
