Notice of Application for a Planning Permit

The land affected by the application is located at:		CP160992 5 Myrtle Grove, Guys Hill VIC 3807	
The application is for a permit to:		Use and Development of Land for a Small Second Dwelling and Removal of Native Vegetation	
A permit is required under the following clauses of the planning scheme:			
35.05-1	Use of Land for a Small Second Dwelling		
35.05-5	Construct a building or construct or carry out works associated with a Section 2 Use (Sma Second Dwelling)		
35.05-5	Construct a building within nominated setbacks		
42.01-2	Construct a building or construct or carry out works		
42.01-2	Remove, destroy or lop vegetation		
52.17-1	Remove, destroy or lop native vegetation (including dead native vegetation)		
APPLICATION DETAILS			
The applicant for the permit is:		AJ's Drafting Service	
Application number:		T250503	
		d any de come ante thest come ant the

RE: 5 Myrtle Grove, Guys Hill VIC 3807

The proposed works consists of a second small dwelling, situated along the south side of the existing dwelling. Along with a minor site cut (500mm), retaining wall (400mm high) and the removal of one tree.

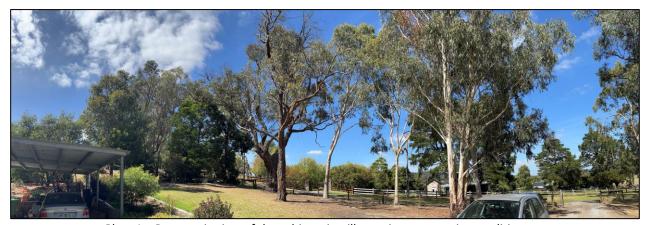
The site supports a single storey brick dwelling with an attached carport. The site is accessed via a crossover and gravel driveway located off Myrtle Grove. Vegetation within the site is mainly comprised of native Australian species, mostly planted with some remnant trees scattered around the site.

Plate 1 – Panoramic view of the subject site, illustrating current site conditions.

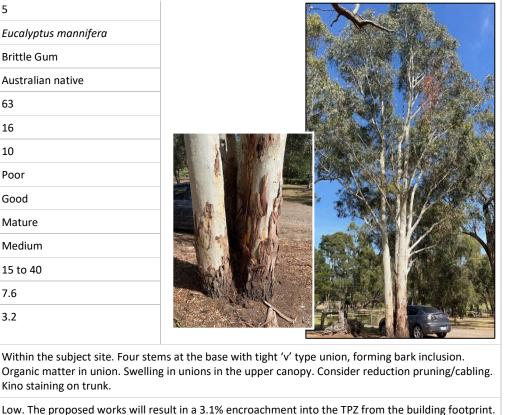
Tree #	5	
Species	Eucalyptus mannifera	
Common name	Brittle Gum	
Туре	Australian native	
DBH (cm)	63	
Height (m)	16	
Spread (m)	10	
Structure	Poor	
Health	Good	
Age	Mature	
Amenity value	Medium	
ULE (yrs)	15 to 40	
TPZ (m)	7.6	WAR SHE
SRZ (m)	3.2	
Notes	Within the subject site. Four Organic matter in union. Sw Kino staining on trunk.

Fill is proposed within this section of the dwelling, root severance and tree related impacts are

therefore expected to be minimal.

Consider cabling if retention is planned long-term or consider removal.

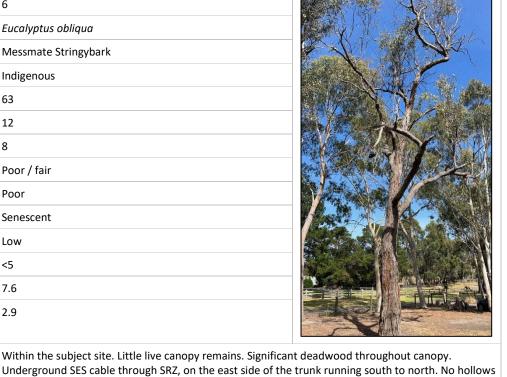
Proposed for removal. Protected under ESO1, removal requires council approval.

The siting the proposed SSD was selected with the desire to minimise the impact to native vegetation. This siting has resulted in the need to remove a single tree. The arborist assessment is that the subject tree (Tree 6) is senescent, in poor condition and of low amenity value with less than 5 years Useful Life Expectancy. It was further noted that little live canopy remains with significant deadwood throughout canopy and that no hollows were observed.

Tree 6's trunk is located within the proposed building footprint; therefore, retention is not feasible with the current design. Tree 6 is indigenous and protected under ESO1 provisions, and its removal will require council approval. The tree is in poor condition, contains no visible hollows, and offers limited landscape and ecological value.

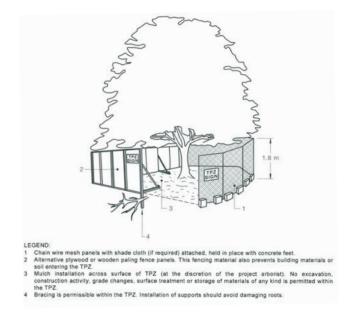
A TPZ area may surround a single tree or group, or a patch of vegetation. Activities

Source – AS 4970-2009 Protection of trees on development sites (Tree Protection)

that must NOT be carried out within a TPZ unless permitted by the Responsible Authority include, but are not limited to, the following:

- (a) machine excavation including trenching;
- (b) excavation for silt fencing;
- (c) cultivation;
- (d) storage;
- (e) preparation of chemicals, including preparation of cement products;
- (f) parking of vehicles and plant;
- (g) refuelling;
- (h) dumping of waste;
- (i) wash down and cleaning of equipment;
- (j) placement of fill;
- (k) lighting of fires;
- (I) soil level changes;
- (m) vehicle movement access ways;
- (n) changes of grade;
- (o) temporary or permanent installation of utilities and signs, and
- (p) damage to the tree.

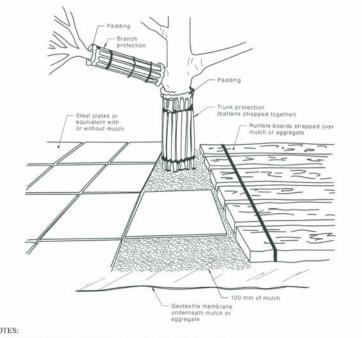
- NOTES:
- 1 For trunk and branch protection use boards and padding that will prevent damage to bark. Boards are to be strapped to trees, not nailed or screwed.
- 2 Rumble boards should be of a suitable thickness to prevent soil compaction and root damage.

Source - AS 4970-2009 Protection of trees on development sites (Ground Protection)

For machinery access within the TPZ, ground protection should be utilised to prevent root damage and soil compaction. Measures may include a permeable membrane such as geotextile fabric beneath a layer of mulch, or crushed rock below rumble boards or HPDE track mats. These measures may also be applied to root zones beyond the TPZ.

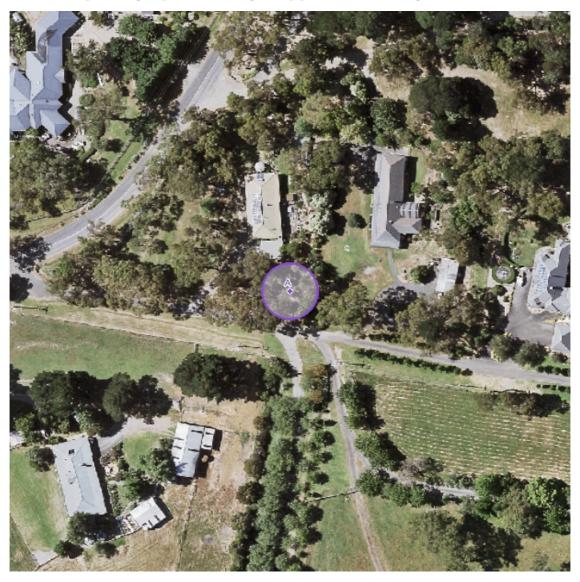
2. Aerial photograph showing mapped native vegetation

Proposed Removal

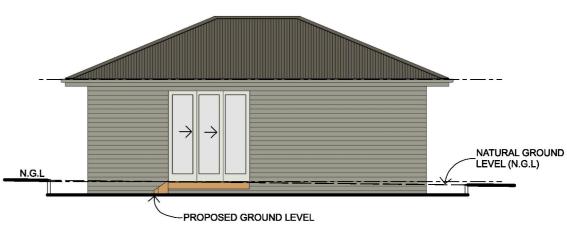
EAST ELEVATION

ROOF: COLORBOND 'GULLY'
WALLS: HARDIE OBLIQUE 'DUNE'
GUTTERS/TRIMS: COLORBOND 'DUNE'
